Performance Evaluation of Insulation in 10 kV Switchgear through Partial Discharge Analysis

Switchgear acts as the heart of the power distribution and transmission system, namely in the medium voltage system. If the switchgear insulation does not function properly, the risk of interference, equipment damage, and even accidents that endanger human safety can increase. One of the problems that often occurs in insulation is a phenomenon known as partial discharge (PD). PD is an electrical discharge that occurs in the insulating material and is often a sign of damage or defects. Although PD does not always immediately cause failure, if left unchecked, continuous PD activity can damage the insulating material and cause more serious damage. Partial Discharge testing uses a device called Ultra TEV plus 2. The TEV method focuses on measuring transient voltages caused by partial discharges on the surface of an insulator or within electrical equipment. Essentially, PD emits electrical signals that can be measured as voltage changes. Meanwhile, with the ultrasound method, ultrasonic sensors are installed near the electrical equipment being monitored. When PD occurs, the sensors capture the u

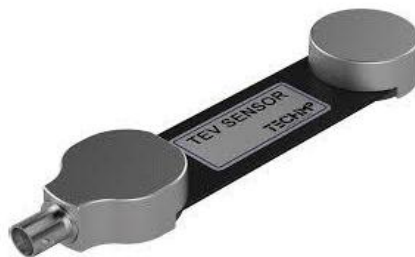
Figure 1. TEV sensor.

The TEV sensor in Figure 1 operates on the basic principle that when a partial discharge (PD) occurs, electromagnetic waves and transient voltages are generated. When PD occurs, the unstable electrical current can cause voltage fluctuations that can be detected on the surface of the electrical equipment. Therefore, the TEV sensor is specifically designed to capture these signals, providing information on the presence and intensity of PDs. After the initial measurements, actual inspections and repairs were conducted at points where high PD activity was detected, followed by retesting. The research flow diagram is shown in Figure 2.

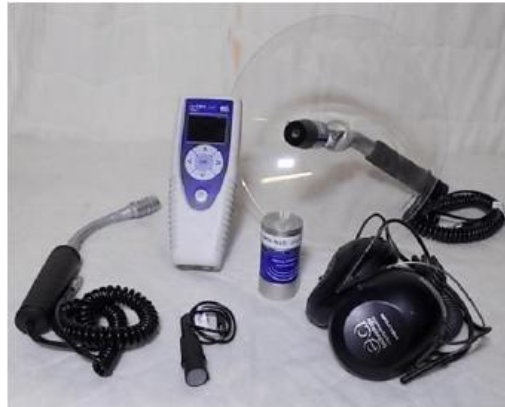
Figure 3. Ultrasound sensor.

In addition to TEV, ultrasonic methods are also invaluable, particularly in detecting and mapping PD sources through the ultrasonic sound waves generated during the discharge process [9]. The combination of these two methods can provide a more complete and accurate picture of insulation conditions. When partial discharge (PD) occurs, this phenomenon generates ultrasonic acoustic waves that propagate through the insulation material and the surrounding air. These sound waves have a frequency higher than the human ear can hear, typically above 20 kHz [10]. To detect these sound waves, specially designed ultrasonic sensor, as shown in Figure 3.

This sensor captures the ultrasonic waves generated by the PD and converts them into an electrical signal that can be analyzed. By analyzing these signals, technicians can determine the location and intensity of the PD. Ultrasound methods offer a non-invasive way to detect PD. Ultrasonic sensors are installed near the electrical equipment being monitored. When a PD occurs, the sensor captures the resulting ultrasonic waves and converts them into a signal that can be

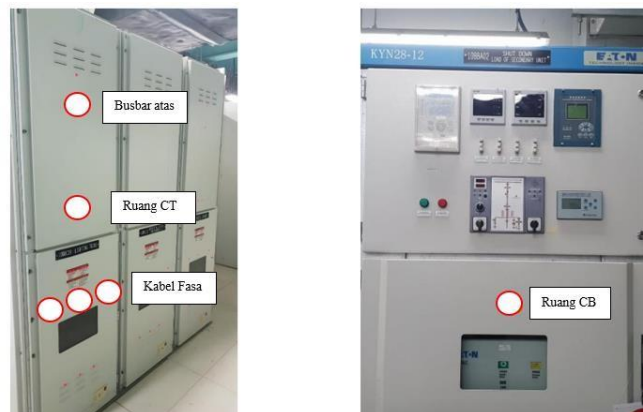
Figure 4. PD testing position.

further analyzed. PD testing position on 10kV switchgear cubicle using TEV and Ultrasound methods shown in Figure 4.

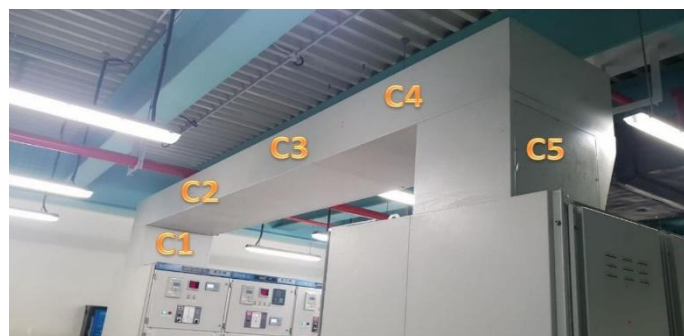
Figure 5. PD test location on a bus duct using the TEV and Ultrasound methods.

Ultrasound measurements are performed using sensors specifically designed for this purpose. Data obtained from the sensors are then analyzed to identify PD patterns and characteristics. This analysis process can include signal processing, frequency analysis, and mathematical modeling, all aimed at improving detection accuracy and providing clearer information about the insulation condition, as shown in Figure 5.

During the data collection process, several critical points were selected as measurement locations to ensure comprehensive coverage. These points include the R-phase cable, the S-phase cable, and the T-phase cable, which are the main current-carrying paths. Additionally, measurements were also taken at the overhead busbar, the Current Transformer (CT) room, and

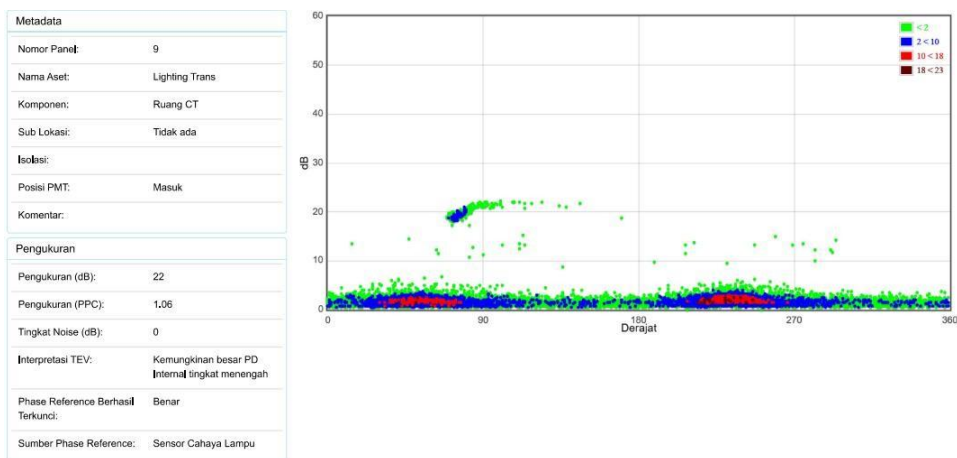
Figure 7. Graph of measurement results of 10BBC09 CT room using the TEV method.

The results indicate the possibility of moderate and high levels of partial discharge. These results are based on analysis using the Ultra TEV Plus 2 instrument. Several graphs also show partial discharge in the 10kV switchgear cubicles 10BBC08, 10BBC09, and 10BBC10.

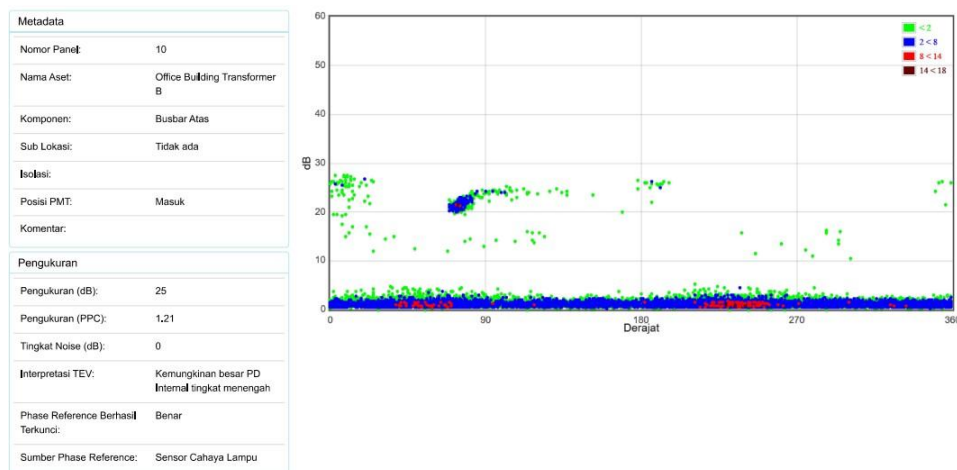
Figure 8. Graph of the results of measuring the 10BBC10 upper busbar using the TEV method.
